# **Alaska FACE**

### **Worker struck by side ring of multi-piece (split) rim during wheel installation**

**FACE 03AK006**

**Released: December 12, 2003**

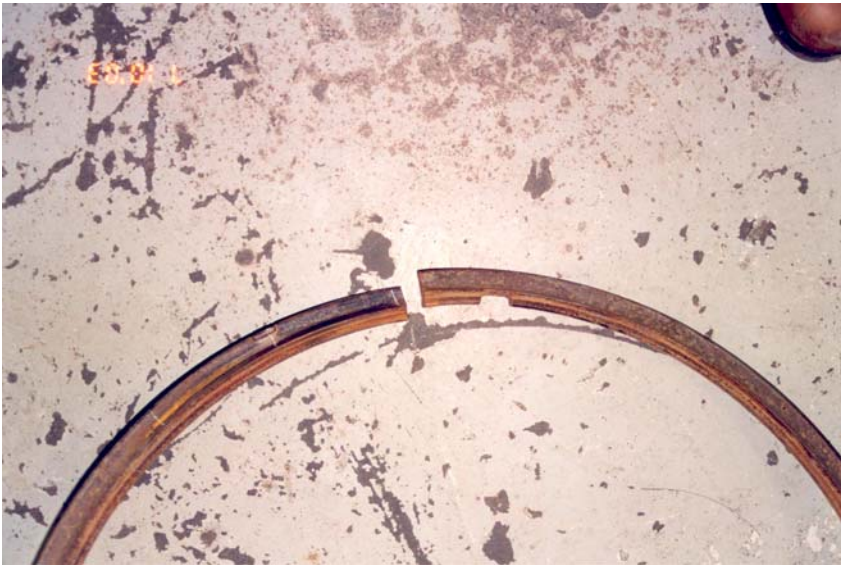
**Figure 3. View of deformed or “sprung” split locking ring**

Post-incident inspection of the rim assembly by an AKDOLWD Occupational Safety and Health Enforcement Officer found that the parts were matched but severely pitted due to heavy corrosion. The locking ring was deformed or "sprung" (Figure 3), and the heavy corrosion obscured the identification stamping, indicating the parts were not cleaned and inspected prior to remounting. All of the aforementioned observations may have been contributing factors in this incident. In addition, post-incident inspection of the maintenance shop found Demounting and

**Recommendation #1: Employers should establish an inspection program for all (used and new) multi-piece rims to ensure proper matching of parts and serviceability.**

Improper handling, poor assembly, and lack of inspection of rim parts have been identified as direct and contributory factors leading to rim failure. Employers should establish an inspection program for all multi-piece rims. This should include new parts placed in storage. Rim parts should be inspected for any damage and deformity, such as cracks, bent areas (sprung locking rings and irregular, noncircular shape), wear, corrosion and pitting, and welds. Any questionable part should be immediately removed from service and permanently discarded. New parts that

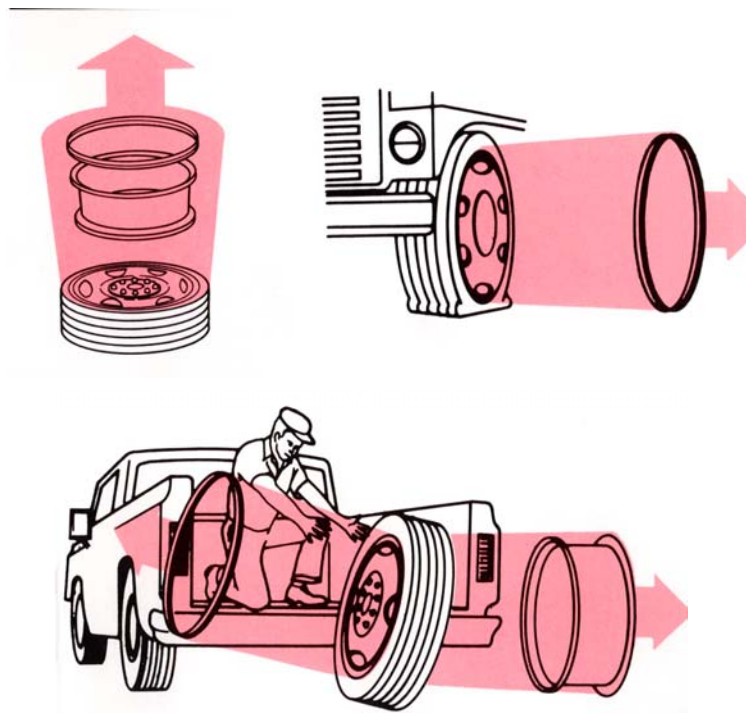
**Figure 4. Trajectory of multi-piece rim parts**

OSHA safety standards for the demounting, servicing, and remounting of single- and multi-piece rim wheels have significantly reduced worker injuries, but it does not eliminate injury that may occur from sudden release of rim parts during transport, movement and installation. Workers should also be trained on avoiding of any potential path that rim parts may travel (trajectory) and minimizing or eliminating activities within trajectory (Figure 4).
